Service Bulletin

ExpressCard Main Logic Board (MLB) Handling and Troubleshooting Document Number D998200325-10

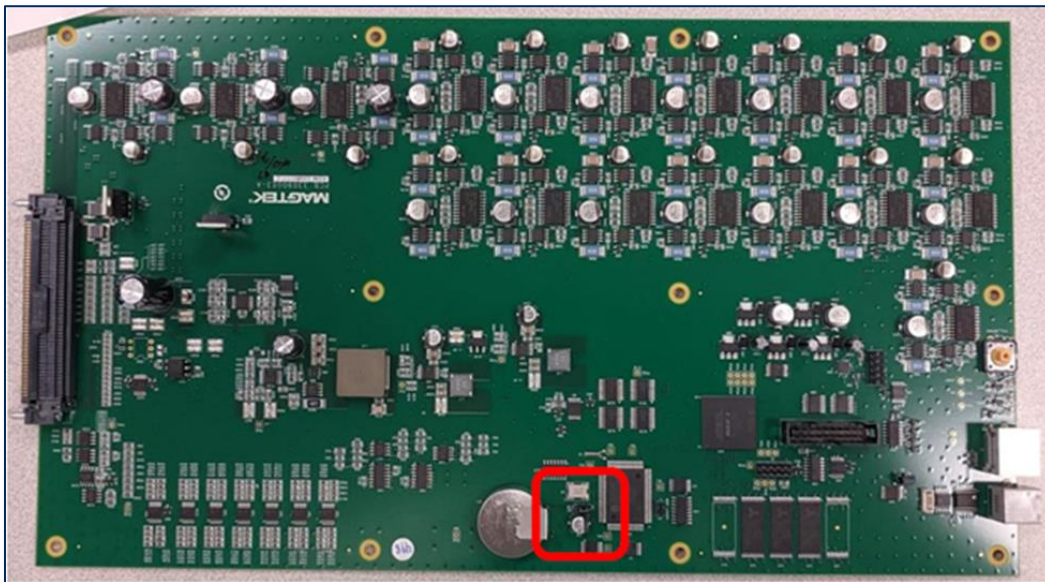
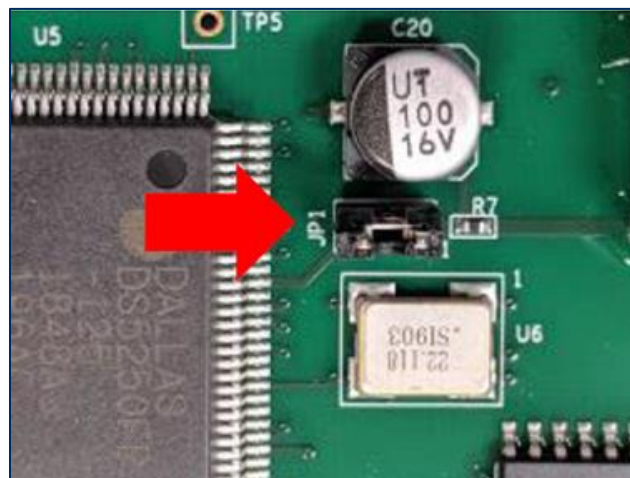
When handling or working around the MLB, **be careful not to remove jumper JP1**, shown in the photos below. Removing this jumper triggers a security response that completely erases the MLB's bootloader firmware. Restoring the device's functionality in this case requires reloading the bootloader, which requires an RMA to return the MLB to the manufacturer for rework or replacement.

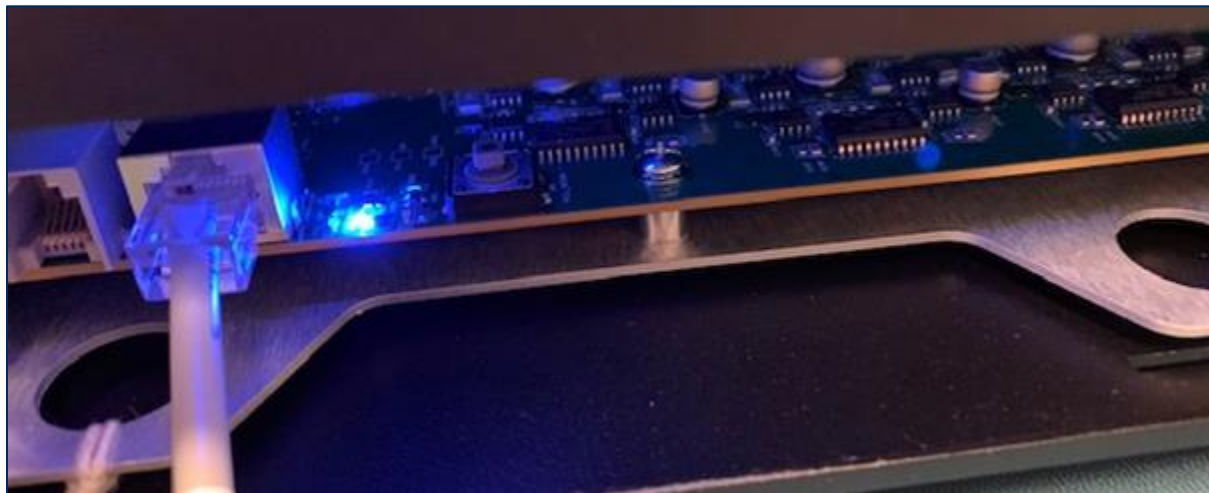
- 1) **MLB LEDs:** Power on the device and observe the LEDs on the edge of the MLB facing the left side access door. In normal operation, the green LED **D1** is solid for 10-20 seconds during power-up initialization, then begins blinking. If **D1** does not turn on at all, as shown below, the MLB no longer has working bootloader firmware and must be returned to MagTek for service.

- 2) **Touchscreen / External Controller:** After a period of time, the touchscreen or external controller PC's display pops up an error dialog box reporting **Unable to start the MTECJobServer**. If an operator presses the **OK** button to close the dialog box, the touchscreen reports **Offline** as the device status, and **Error Opening Controller** as the reason.
- 3) **Remote Host:** A host sending transactions to the device using the network API receives responses containing Return Code **65**, **Error Opening Controller**.
- 4) If the device is exhibiting these behaviors, contact MagTek Support Services to make arrangements for RMA rework or replacement.
